SAFETY ALERT

Operating mobile plant – incidents and near misses

CM9 reference	DOC20/784056
Mine safety reference	SA20-09
Date published	1 October 2020
Authorised by	Chief Inspector Office of the Chief Inspector

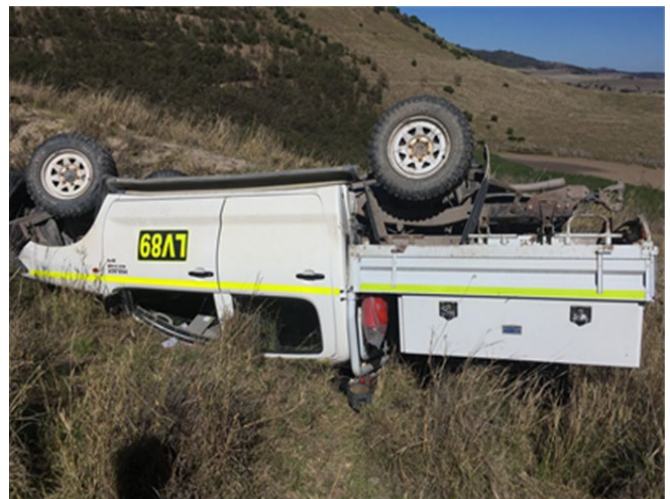
Figure 1 Light vehicle rollover on mine rehabilitation

It is recommended that mine operators ensure:

- all mining areas including roadways, intersections and park up areas are designed, constructed and maintained to safely manage:

- interactions between mobile plant and light vehicles
 - interactions between mobile plant and equipment
 - interactions between mobile plant and fixed plant and structures
 - interactions between vehicles, mobile plant and pedestrians.
- pre-use inspections are conducted on vehicles and equipment, and all defects are reported and repaired
 - workers are trained and competent to operate vehicles and equipment
 - vehicle and equipment operators attend work, physically and mentally capable of performing their duties (fitness for work)
 - vehicles and equipment are operated within their design limits
 - vehicles and equipment are operated according to the environment (drive to conditions)
 - positive communication (the use of equipment numbers) is always applied when operating vehicles and equipment.

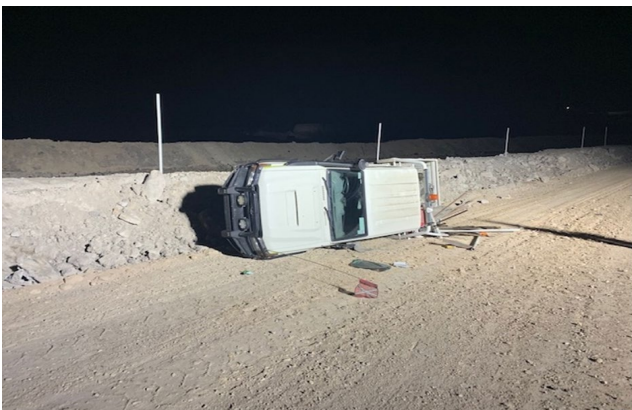
Figure 1 Light vehicle rollover in mining area

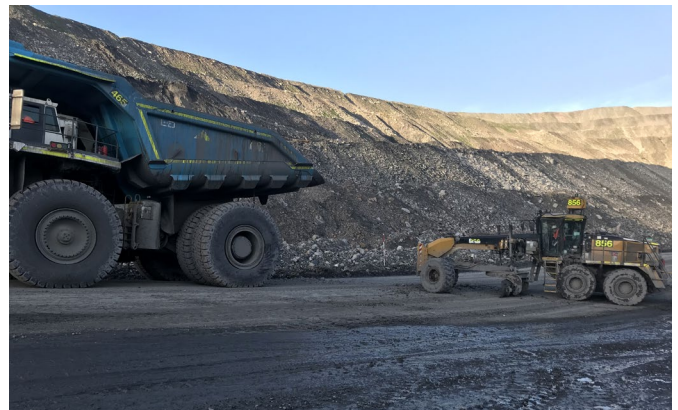
Figure 2 Contact between haul truck and grader
